June 5, 1987

FROM: Frank J. Filas, Reclamation Engineer

RE: Site Inspection, Mi Vida Mine, M/037/028

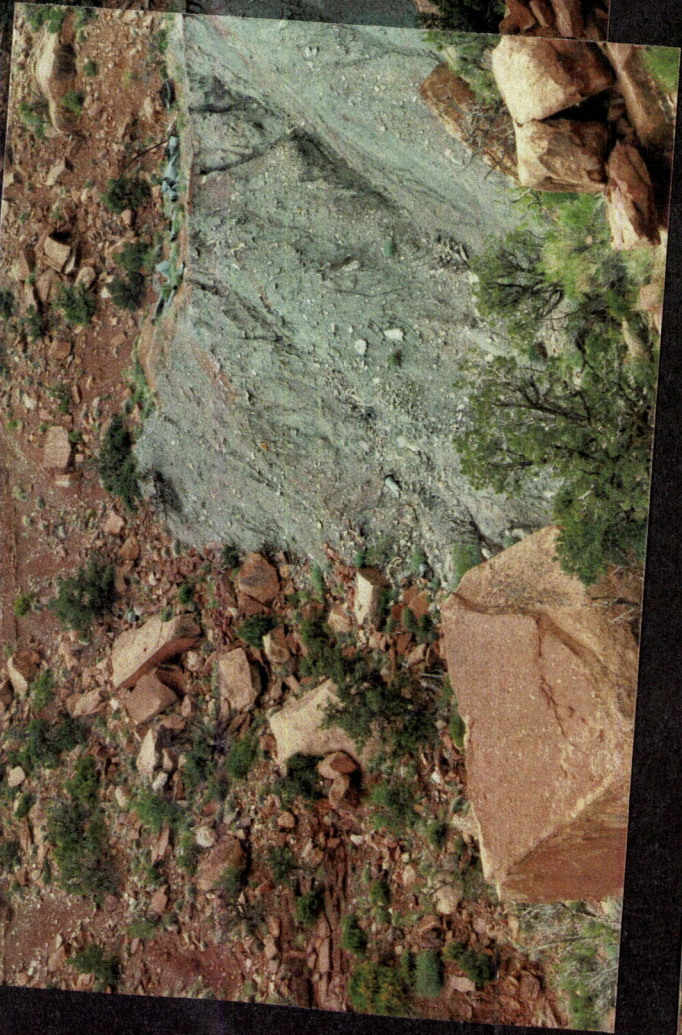
Further down the hill is the McCormick Mine. There is a large waste pile here that blocks most of the drainage. Ore is being hauled out of the associated portal and being dumped down a large metal chute. The ore is being scooped up on the pad below with a frontend loader and into a haul truck.

Dump Point at the McCormick Site  
5/87 M/037/028

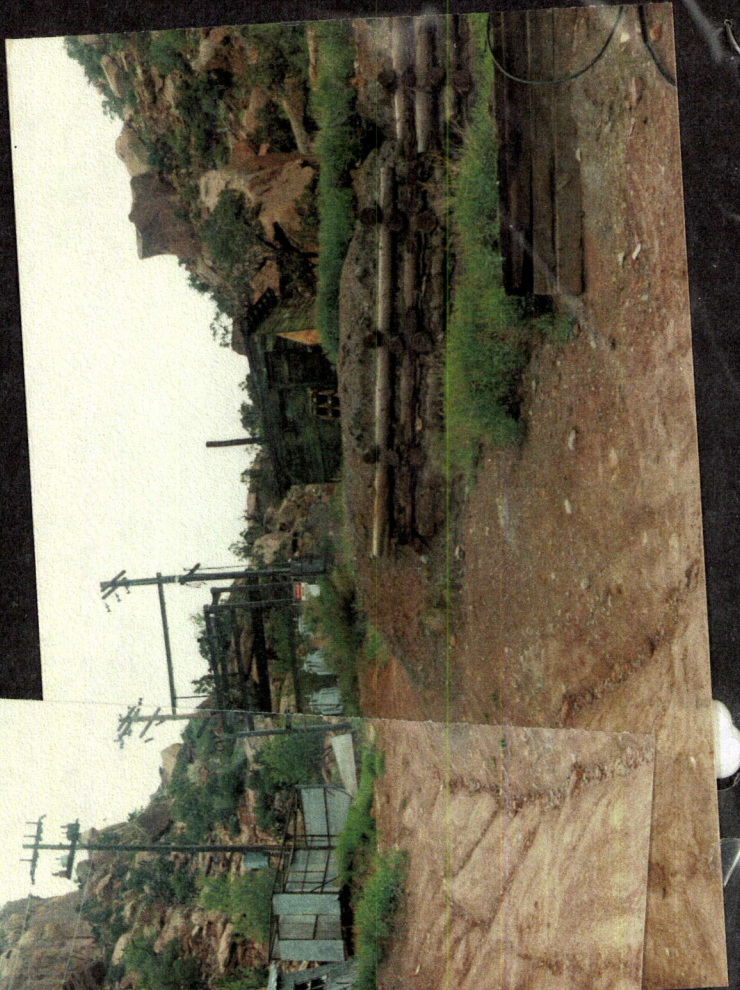
The Expectation portal is in the canyon to the north. It can be reached by following the asphalt road from the McCormick Mine down the hill for several miles and taking the first right onto a dirt road. This road passes by Atlas's Ivy Mine and up to the Expectation Mine. An old waste pile completely blocks the drainage, and water runoff is being routed down the access road. There is a single portal that is being used plus a small pile of spoil material. It is recommended that a culvert be placed in the road to preclude further erosion on the road surface.

M/037/028  
Looking down Canyon from  
Expectation Site

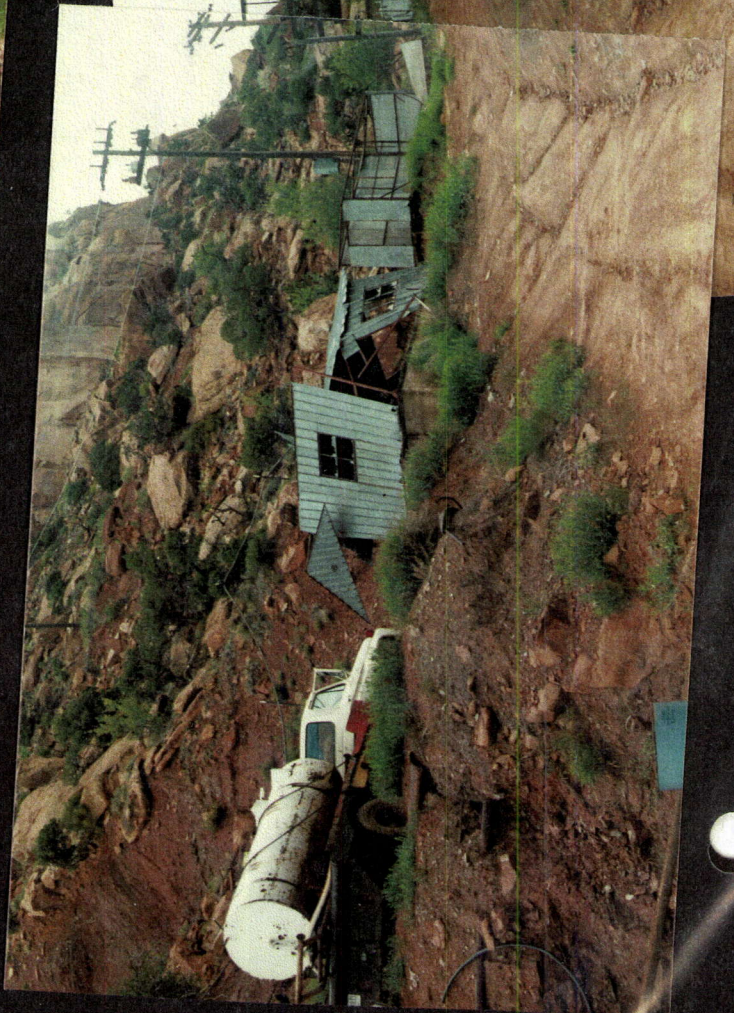
M/037/028 5/87  
McCormick Tunnel
